## 1:0 INTRODUCTION

The Conservation Area Character Statement for Bishopsteignton was endorsed by the Planning Committee on 18 December 2000. Since that time it has been the subject of public consultation, with copies being distributed to the Parish Council and many individuals. It has also been available for download from the Teignbridge website - a facility that has proved very popular. The document was discussed at a public meeting in the village in June 2001.

A review of this Character Appraisal has been undertaken and its effectiveness was considered and necessary amendments made. Fieldwork carried out 10th September 2009. The revised Appraisal was approved on 22nd March 2010.

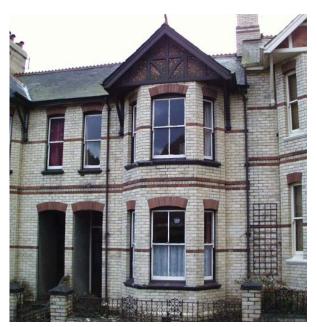
Attractive Victorian terraced houses in local buff brick

Along Fore Street are many late 19th century terraced houses, with cast iron railings and moulded brick detailing. Along the Kingsteignton road to the west are a number of lavish villas in extensive grounds, of early-mid 19th century date. The best preserved examples of these are at Friston House, Delamore and Teignlawn. Several have had infill development in their grounds and one, Huntly, has become an hotel. This was so large as to have its own Italianate lodge and cast iron gates flanked by railings.

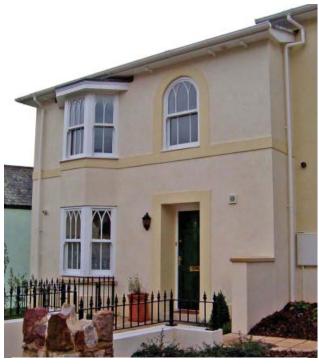
New build reflecting Regency character

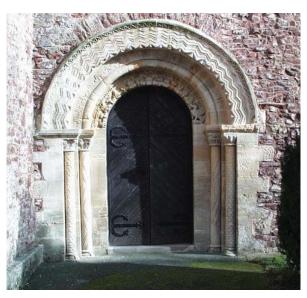
The church is built of local stone, but the decorative elements like the Norman arch are formed in Beer stone.

The church, whose south aisle preserves Norman and Early English work of the 12th-14th centuries, has a particularly attractive Norman west doorway. The original nave is now the south aisle, a typical feature of very early churches.

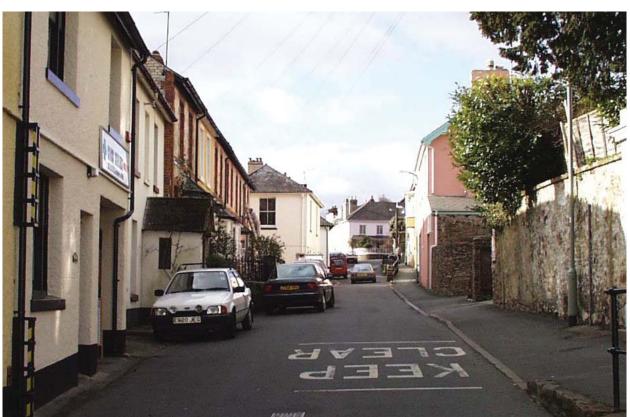
Onstreet parking could be reduced if residents are prepared to develop their own alternatives in conjunction with the District and County Councils.

8:3 MOTOR VEHICLES: Fore Street in particular is prone to traffic congestion which detracts from the ambience of the village centre. On-street parking adds to this problem and is a visual intrusion at other times

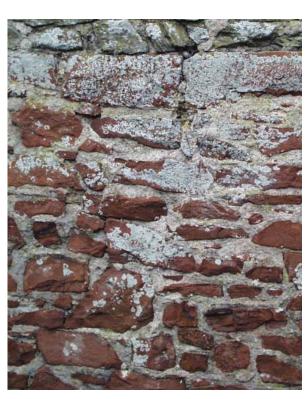
Rubble stone (tuff) wall with lime mortar and lichens.

**ENCLOSURE**: Volcanic tuff and breccia rubble walls,
