Teignbridge District Conservation Area Character Appraisals

Higher Ashton

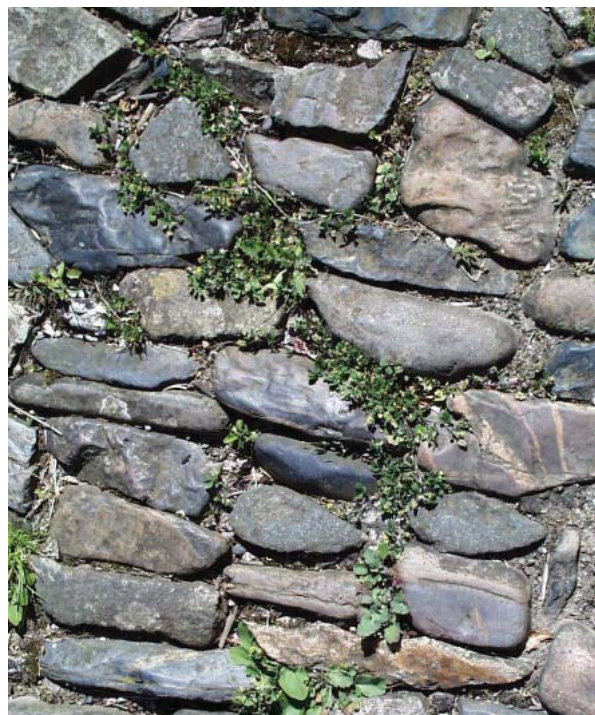
Cobbles reflect the geological variety of the Ashton area

7:1 SURFACING: Some surviving remnants of historic surfacing illustrate the types of treatments used in the past. Waterworn Haldon chert and dolerite cobbles survive on the church paths and the stream beside the lane past Place Barton has exposed a cobbled surface. It is likely that other parts of the village were treated in a similar way in the past. Elsewhere crushed aggregate of varied size and geology is a common surface.

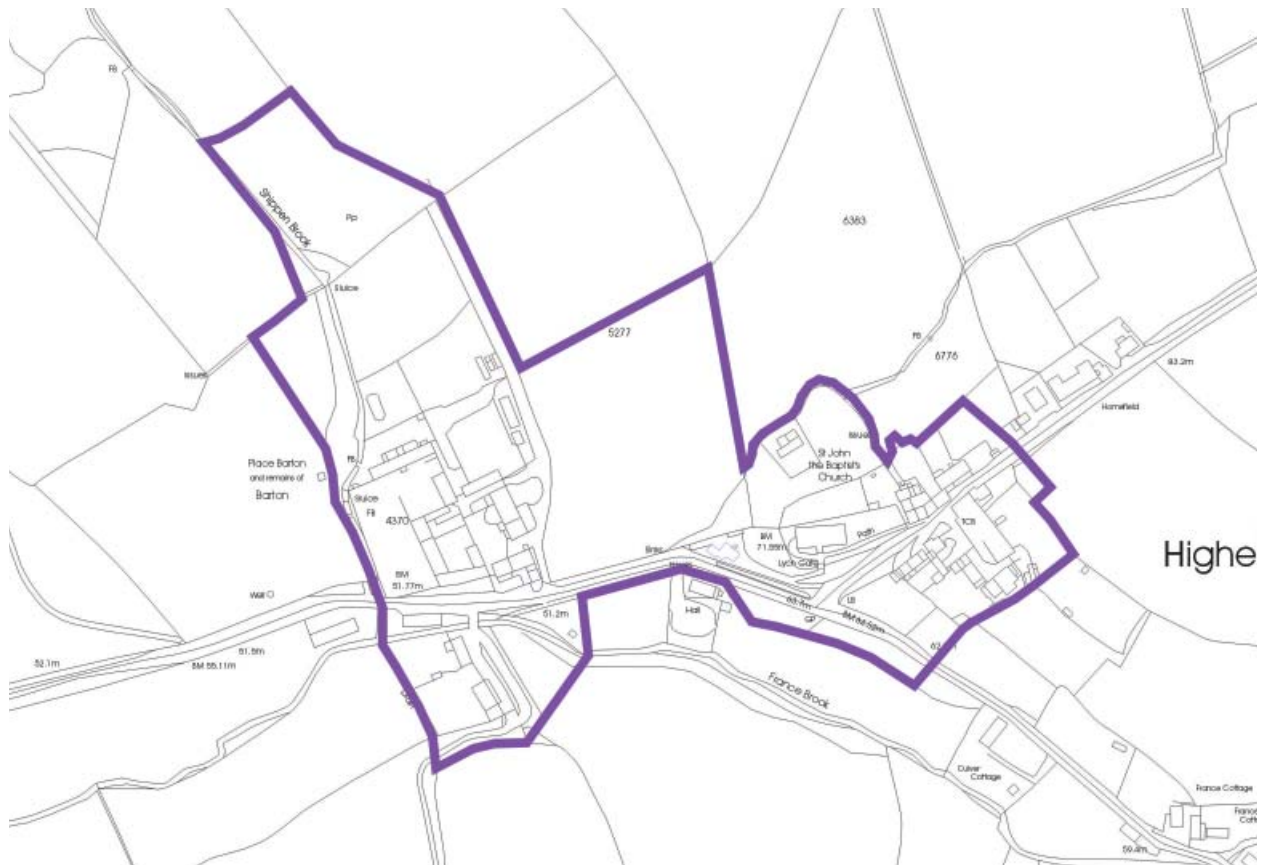
- Archaeological remains in Higher Ashton are particularly important. An Area of Archaeological Potential (see map below) has been identified, taking account of its origins and development and the importance of the surroundings of Place Barton. Any planning applications involving significant excavation within the identified area must be informed by an archaeological investigation.
- The historical development of Higher Ashton will be better understood if it is studied. Further archeological investigation can only reveal more valuable evidence and is to be encouraged.

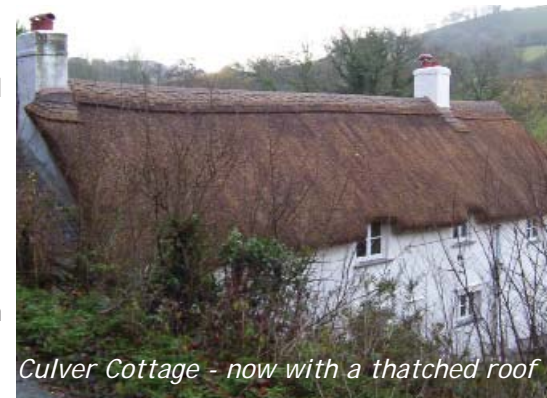
Culver Cottage - now with a thatched roof

Prior to the 19th century, thatch must have been ubiquitous. A few formerly thatched properties in prominent locations, such as Balls Cottages, and Ridgeway Cottages and Culver Cottage would benefit from its revival. Since publication of the initial 'character statement', Culver Cottage had been thatched - a great positive step.

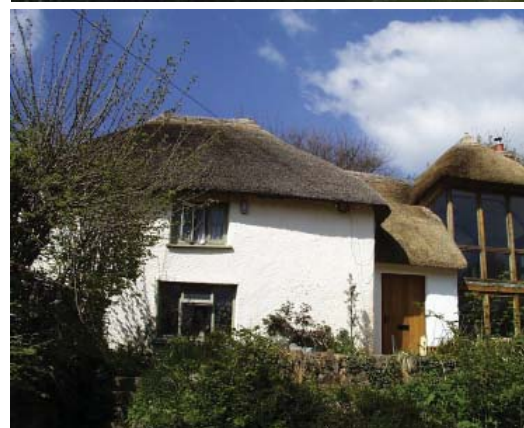
This contemporary extension replaced an unattractive concrete block kitchen.

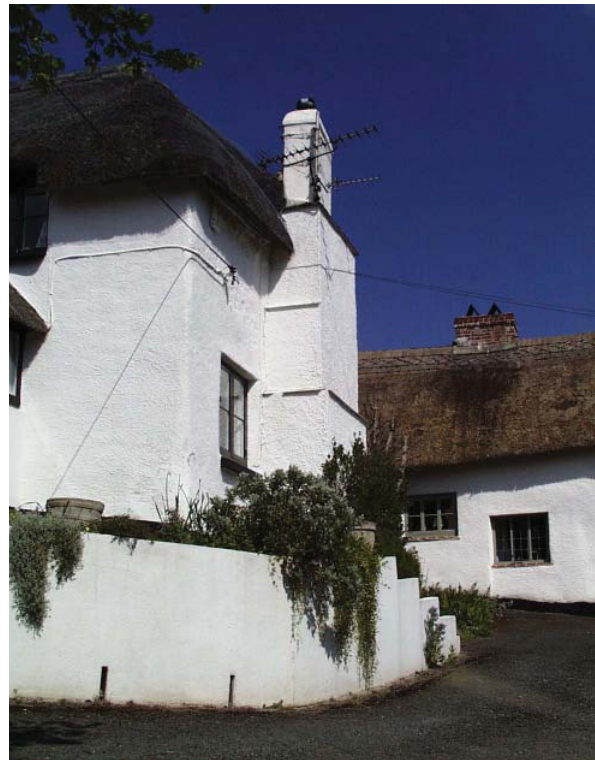
Thatch, rendered walls and large chimneys epitomise the character of Higher Ashton

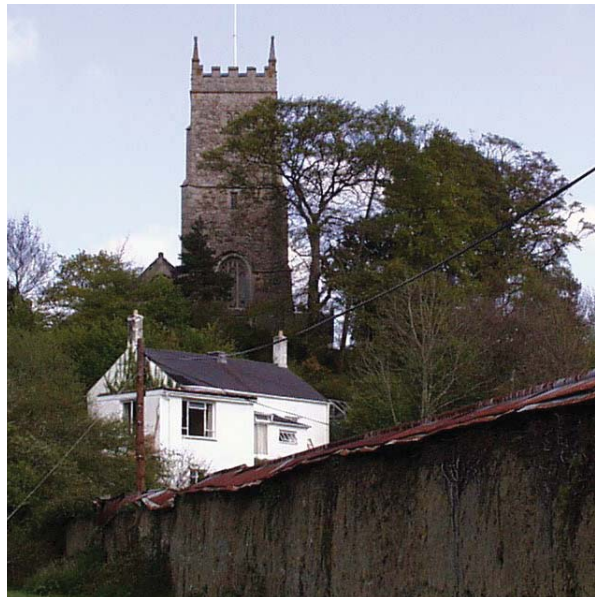
Without repair this cob wall may soon be lost
