# Teignbridge District Conservation Area Character Appraisals

*Kingsteignton*

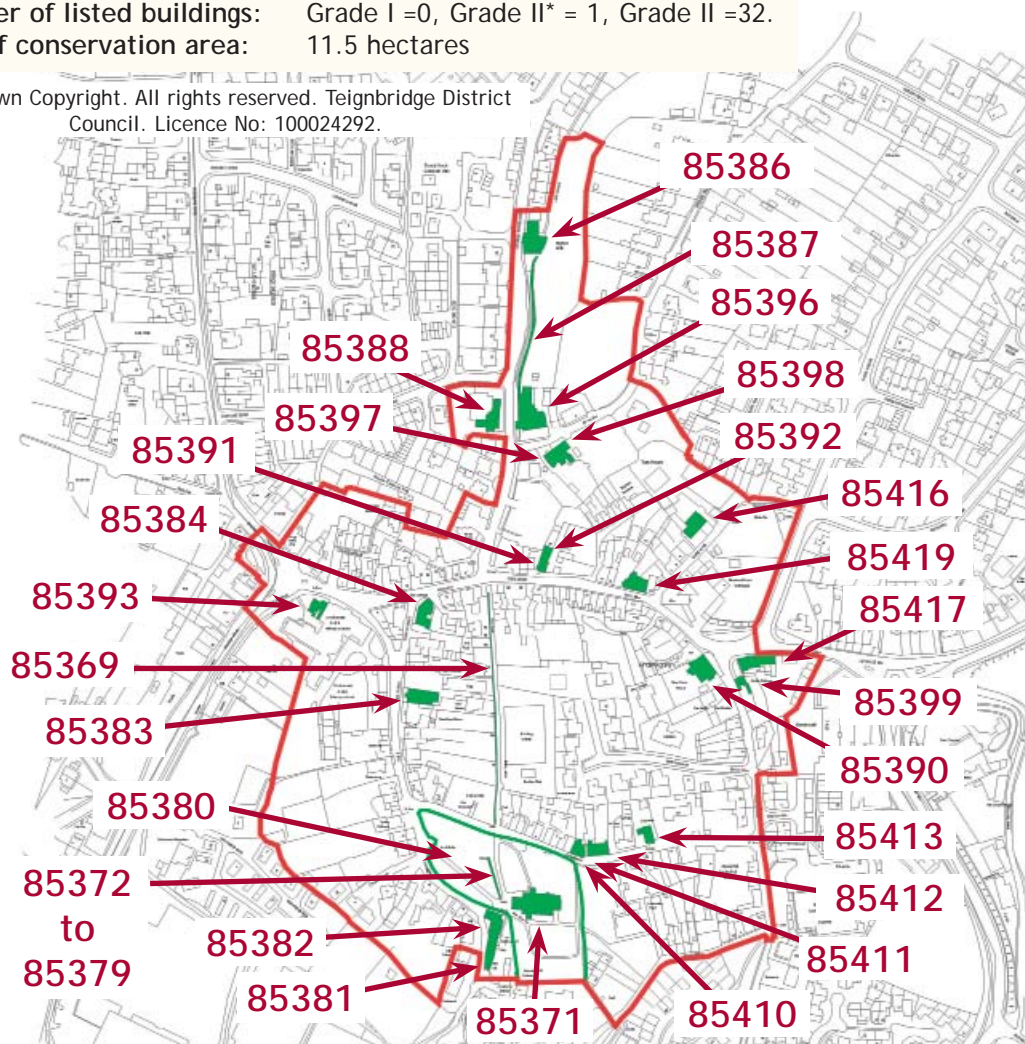
The green coloured areas of this map represent listed buildings that lie within the Kingsteignton conservation area. A summary of these listings may be found in Appendix four.

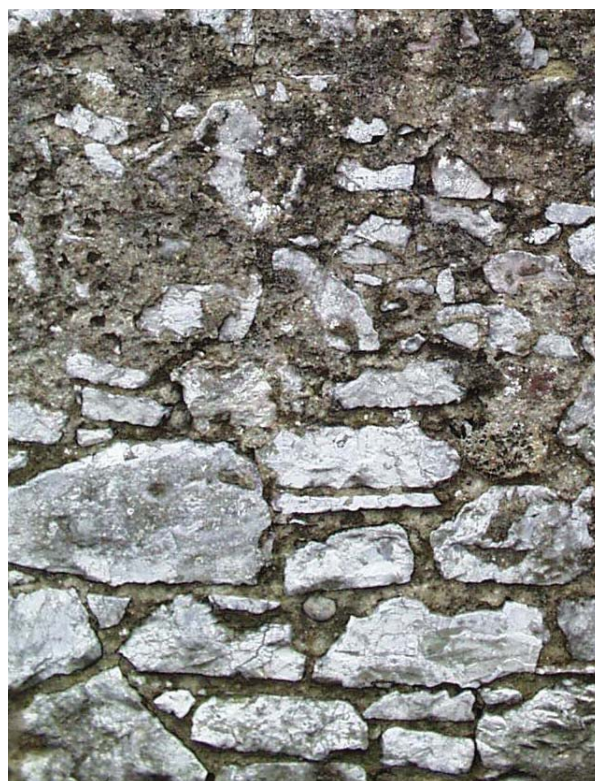
*Pale grey Devonian limestone is prevalent in Kingsteignton.*

The underlying geology consists of relatively recent Oligocene clays with alluvium in the valley bottom at the junction of the B3195. Deposits of upper Devonian slate are outside the village to the east, with middle Devonian limestone on the higher ground to the north-east.

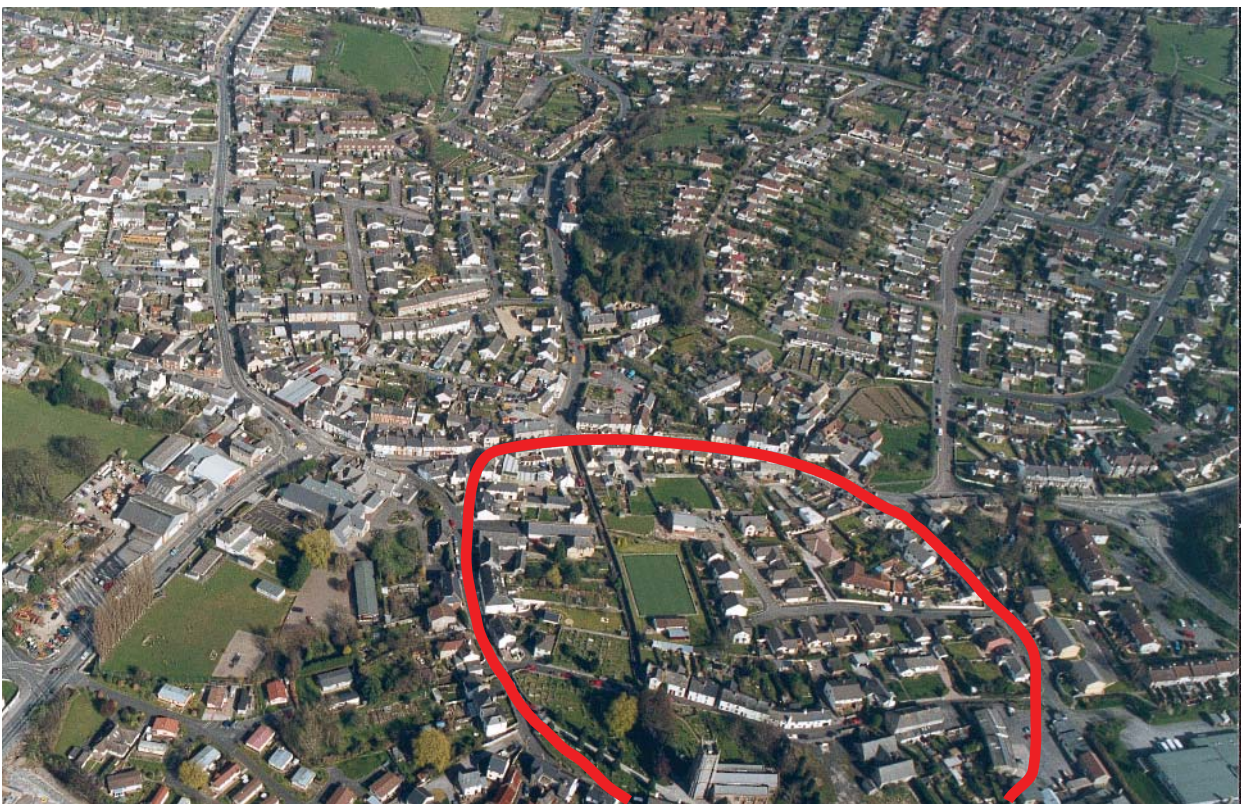
*The ancient core of the village retains a remarkably high concentration of old buildings. Their variety reflects Kingsteignton's change from an open agricultural village to a thriving dormitory settlement based on industry and trade. The large and ancient enclosure marked is indicative of the importance of Kingsteignton in its early times.*

The centre of Kingsteignton contains a large ovoid enclosure, which remains in the street pattern. Such enclosures are a feature of some settlements in south Devon. They commonly enclosed small settlements and fields of Dark Age date (circa 400-800 AD). The parish church is commonly found inside, but near the boundary, as here. Some may have been pre-conquest minsters, (ecclesiastical administrative centres). Future development of the Greenhill industrial estate site could restore an echo of the ovoid enclosure which has been erased here.

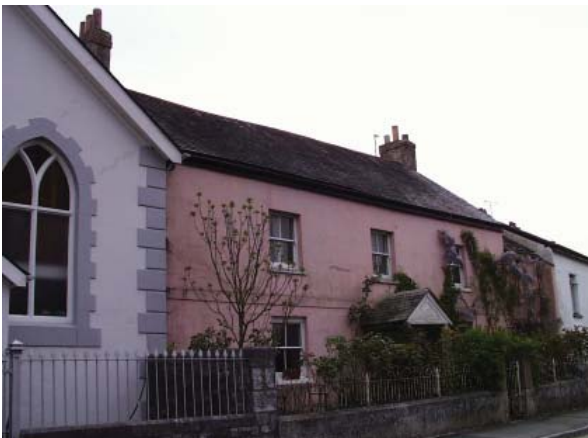
*13 Church St - a fine historic building, surprisingly not listed*

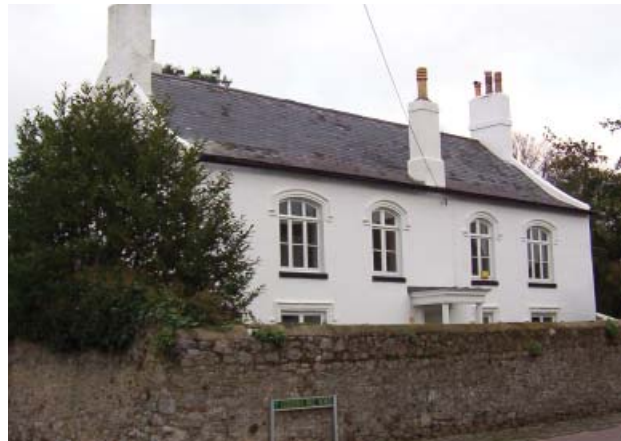
*Brookside - now repainted and restored*

The later, (or re-modelled), thatched properties at 2 & 4 Golvers Hill have tremendous character as does the restored Brookside.

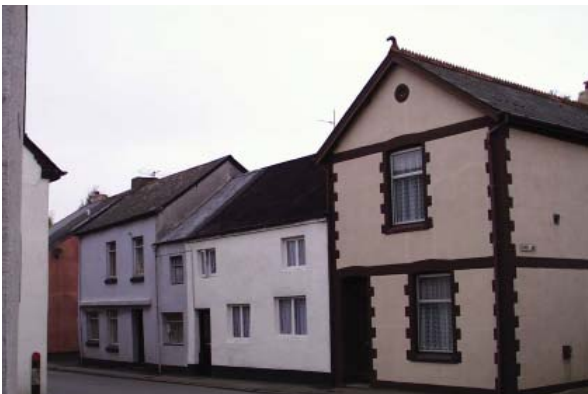
*49 & 51 Fore St are a very rare survival from the 15th century.*

Kingsteignton has a fantastic variety of buildings. There are early houses, such as the 15th century dwelling, (now subdivided into 49 & 51 Fore St), which retains smoke blackened thatch and ancient roof structure beneath its corrugated iron. The scattering of thatched, (or formerly thatched), cottages reflect the original vernacular buildings of Kingsteignton. Good examples include Berry Farm and 19 Crossley Moor Road.

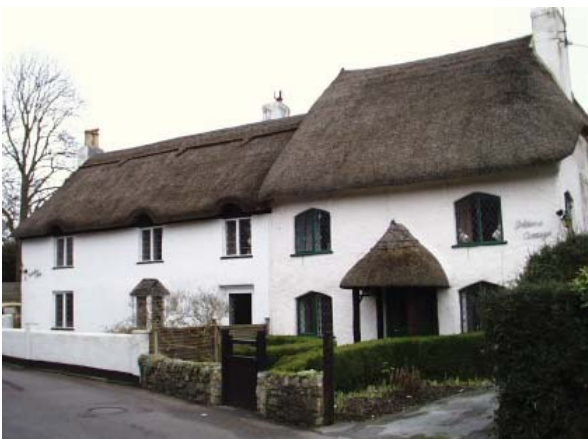
*2 & 4 Golvers Hill*

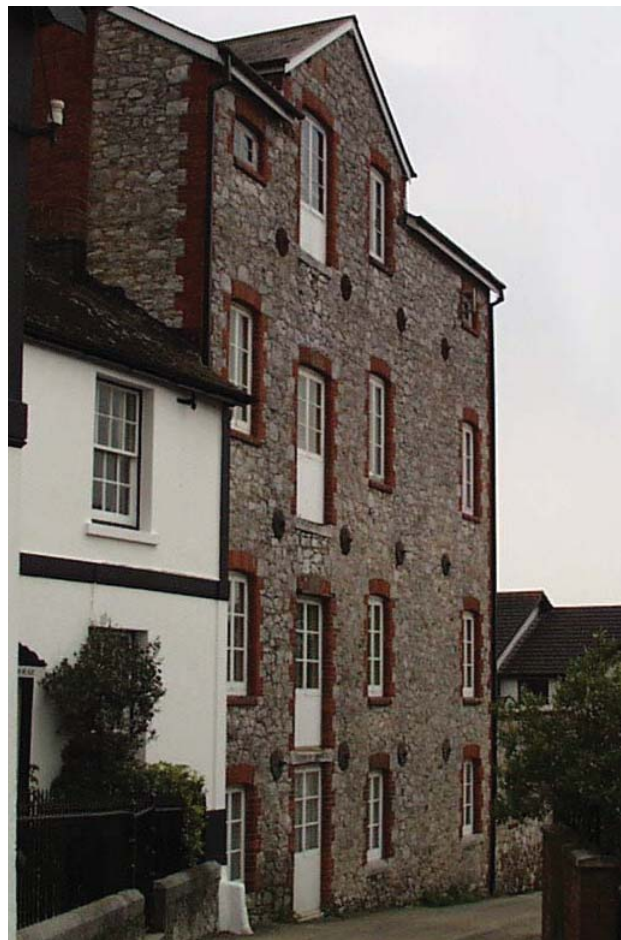
*Lower Mill - an impressive 19th century working building*

The mills are fine buildings. The Higher Mill is an 18th century re-modelling of an earlier building, while the Lower Mill is a Victorian re-build. Having two such fine examples in one village together with such a wonderful leat, is very unusual and special.

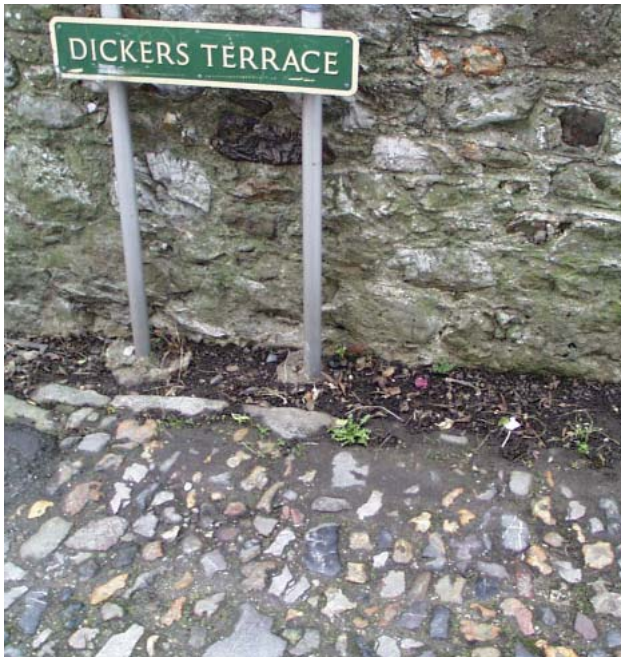
*Some old cobbling survives*

**7:1 SURFACING:** Some surviving remnants of historic surfacing illustrate the types of treatments used in the past. Extensive waterworn Haldon chert and limestone cobbles survive in the narrow lane to Dickers Terrace, while very neat and well-preserved limestone cobbles and edging front Brookside House at the lower end of Golvers Hill Road. Where the mill leat passes through the churchyard, it is culverted under the church path. This is supported on huge stone slabs which make a very attractive feature.

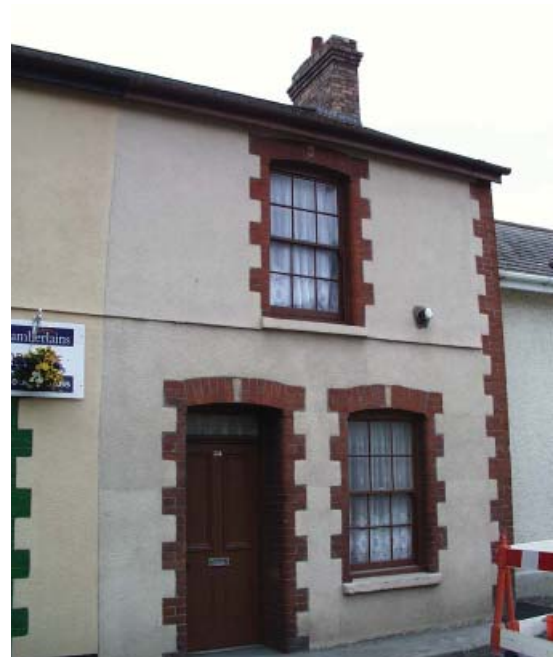
*A simple 19th century dwelling*

Between the oldest buildings are attractive cottages of the 17th and 18th centuries plus a large number of simple 19th century homes. Some of these Victorian buildings are superbly constructed in local limestone and buff brick. Unfortunately none are protected by listing at present.

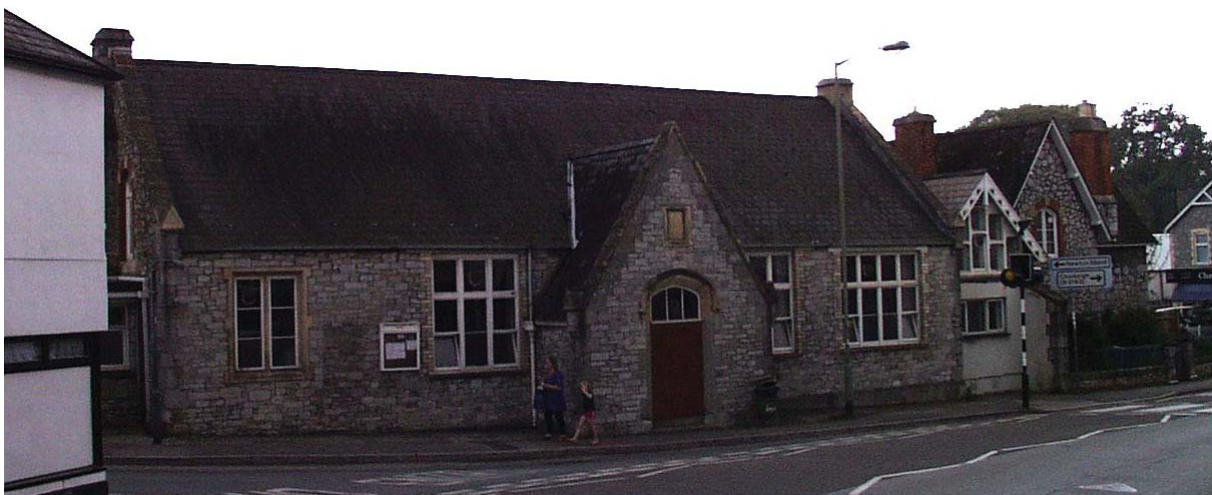
*Devonian limestone is the principal building material but it is rarely exposed*

The older buildings of Kingsteignton are built of rubble stone and cob with a protective coating of render and limewash. Only the church and school exhibit good exterior grade stonework, although grey limestone rubble is a common material in boundary walls, with occasional breccia and waterworn chert from Haldon. The 19th century expansion in local brickmaking saw yellow brick used occasionally for chimneys and quoins. Perhaps surprisingly, this is not a more common material in Kingsteignton. Red brick from Exeter is also found in small quantities in the same contexts.

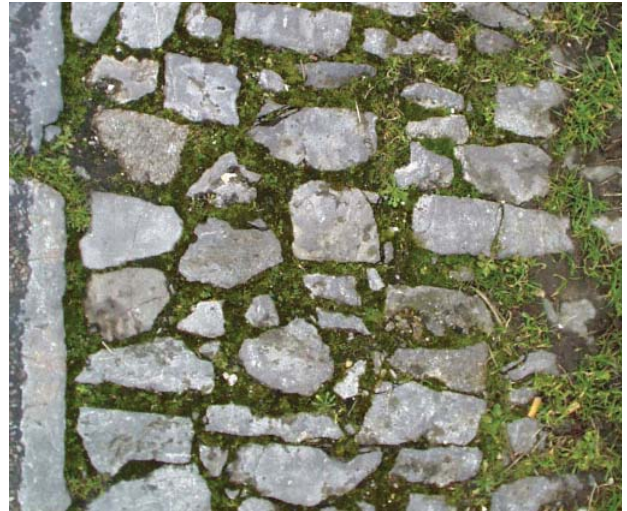
*Angular limestone cobbles are vulnerable to damage by utility companies, etc*

The early 19th century miller's house south of the church has a decorative scheme of limestone cobbles, while later 19th century houses in Fore Street have yellow brick aprons outside, often patterned. It is likely that other parts of the town were treated in a similar way in the past.

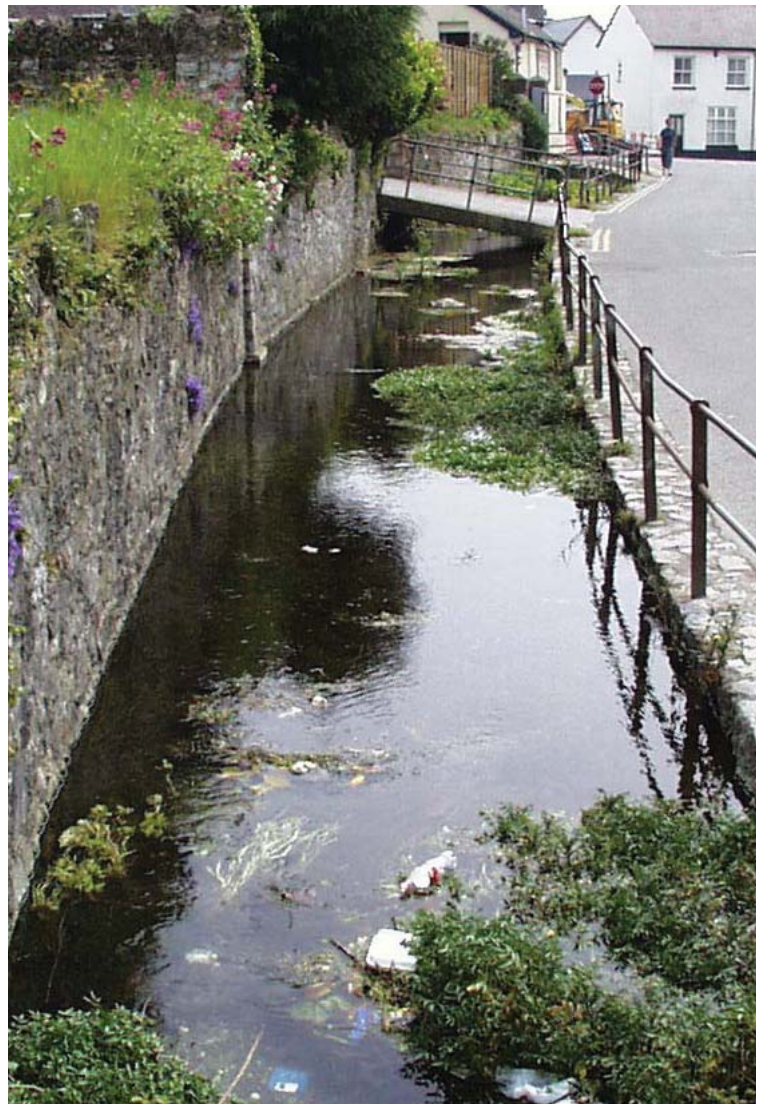
*The leat is the spine of the conservation area and a great historic feature which needs to be well maintained*

**7:5 WATER:** The historic mill leat, flanking Crossley Moor Road and passing through the middle of the Conservation Area provides an attractive link with the past. Where it passes through the area of gardens between Fore Street and Sandpath Road, its course is followed by a footpath, providing access to this characterful area. Where it passes through the churchyard and tumbles into the wheelpit of Lower Mills, it greatly complements the setting of these very attractive buildings.

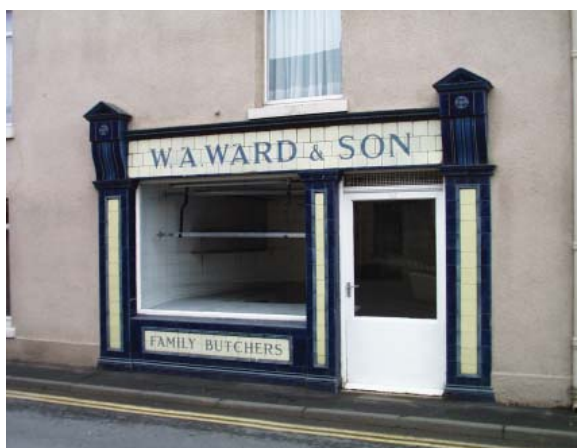
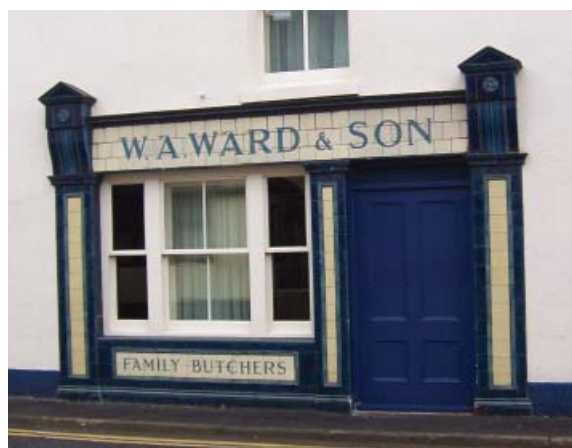
*Before ...*

*After ...*

**7:7 SHOPS:** Several shops are flourishing within Kingsteignton, but care must be taken to avoid unsuitable frontages. Several are presently redundant but their frontages continue to contribute positively to character, especially the former butchers shop on Fore St. It's adaption to residential use has successfully saved this feature.

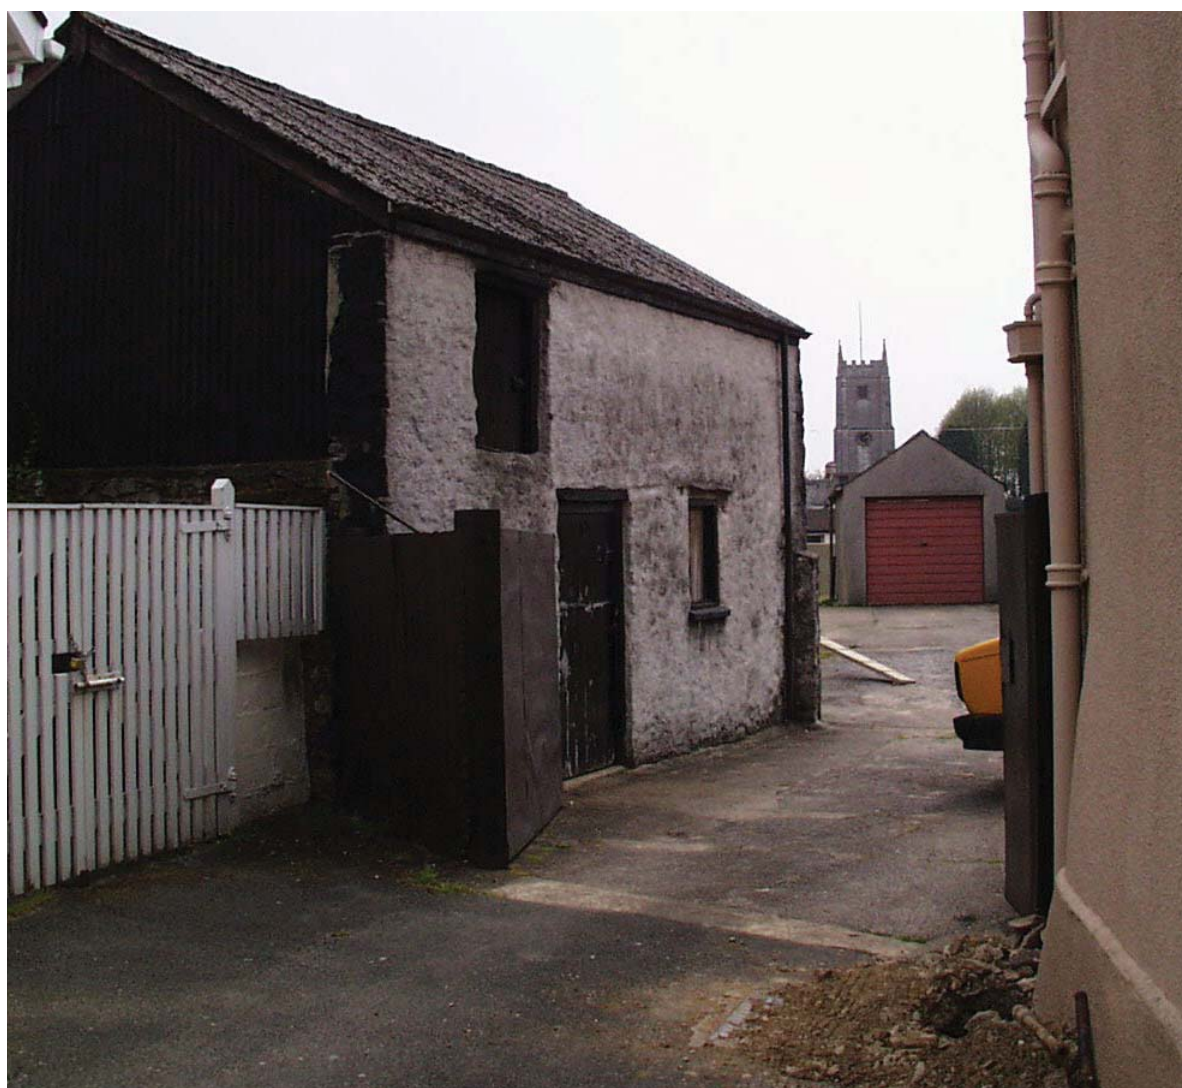
*Glimpsed views of the church and other focal buildings need to be protected as they enrich the streetscene*

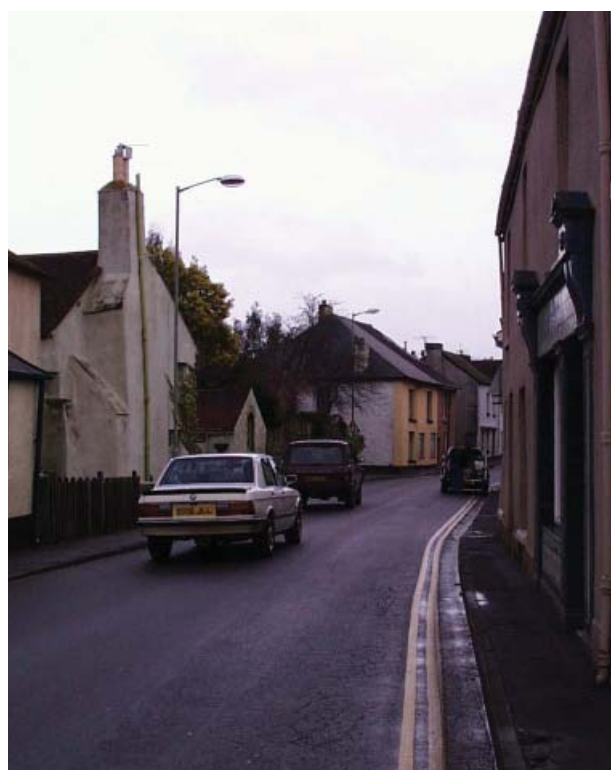
*The pedestrian is not favoured in Fore Street*

**8:1 TRAFFIC:** Since the production of the draft Character Statement, there has been an experimental traffic management scheme in operation in Fore Street. Once an acceptable flow of traffic is achieved it is essential that a quality enhancement scheme is pursued.

Wider pavements incorporating stone kerbing and good street furniture must be a priority. Signage, lines and physical obstructions must be minimal.

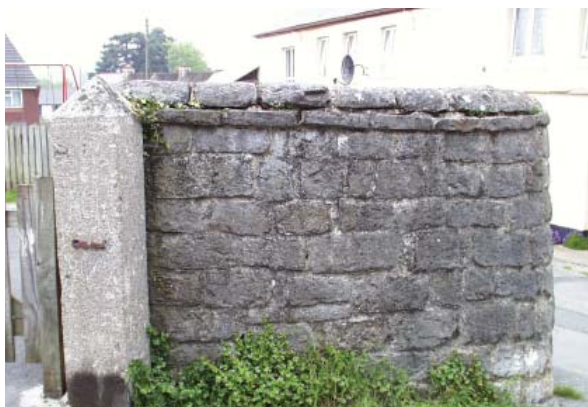
*Limestone walls of varying age and status, are the main method of enclosure*

**ENCLOSURE:** Limestone rubble walls, occasionally with breccia or tuff; bare or limewashed, occasionally rendered and limewashed. Decorative iron railings are a common feature

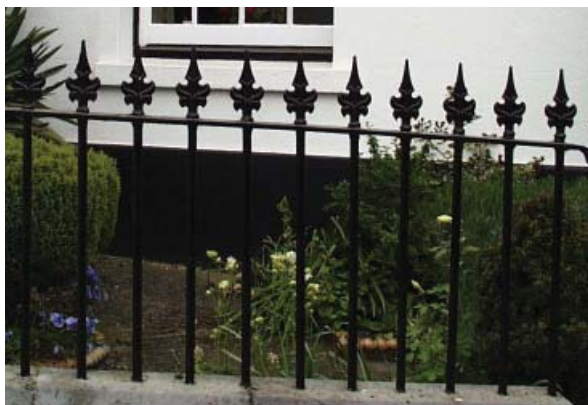
*Railings feature quite prominently throughout Kingsteignton*

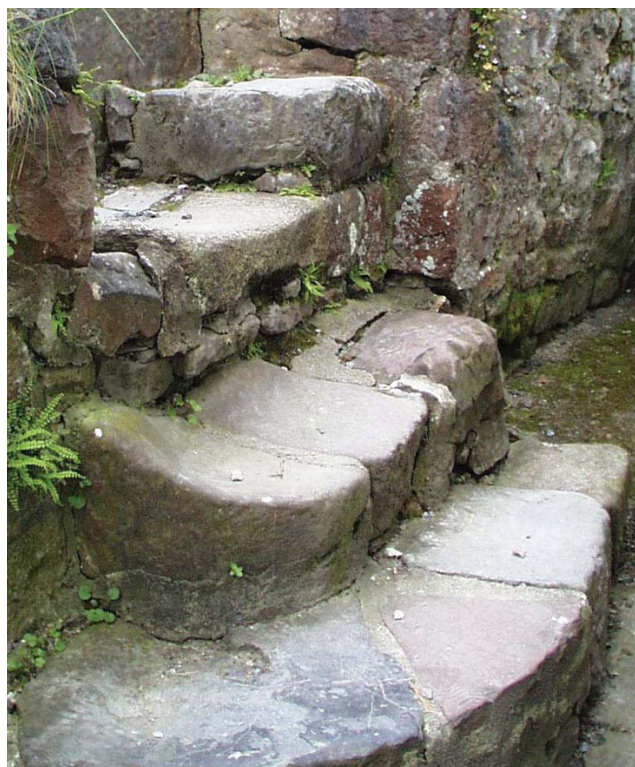
*Churchyard steps smoothed by centuries of use.*

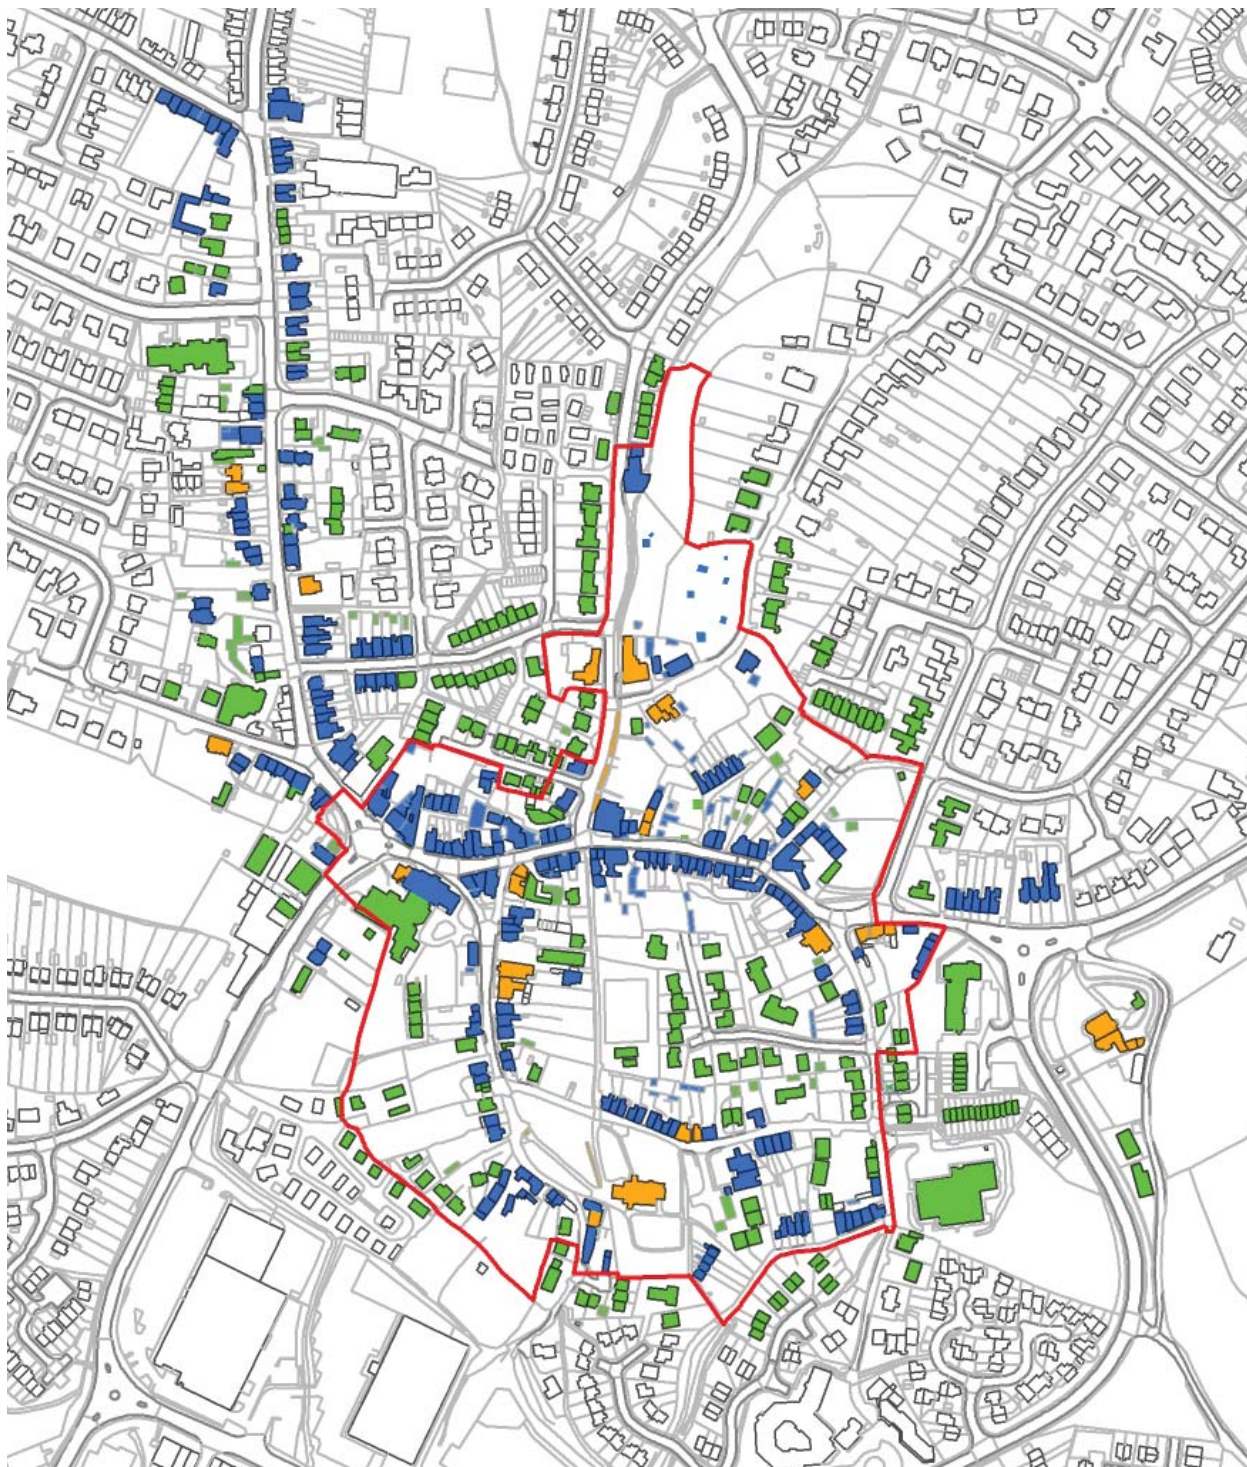
***Key to Character Survey Map***

The purpose of this survey is to identify which buildings within the conservation area contribute positively or negatively to townscape character. Three character bands are used (see map 1) and the criteria for each are summarised below.

Category 1: Outstanding
-

Category 2: Positive
-

Category 3: Neutral/Negative
