Ringmore Conservation Area

Character Appraisal

TEIGNBRIDGE DISTRICT COUNCIL

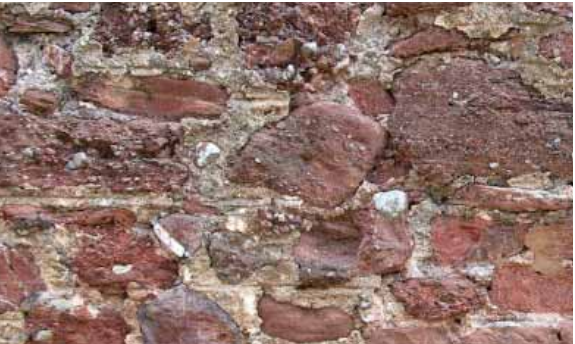
Fig 1 Historic local red sandstone

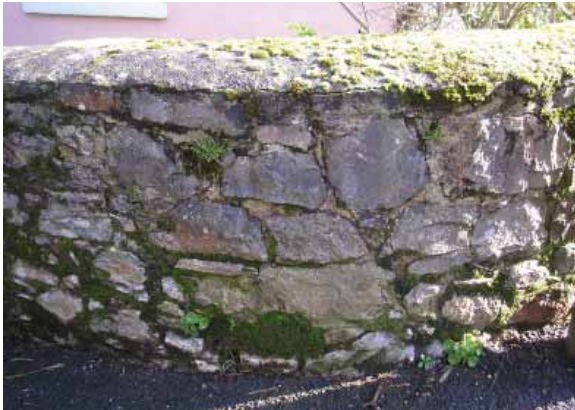
Fig 2 Historic local random rubble

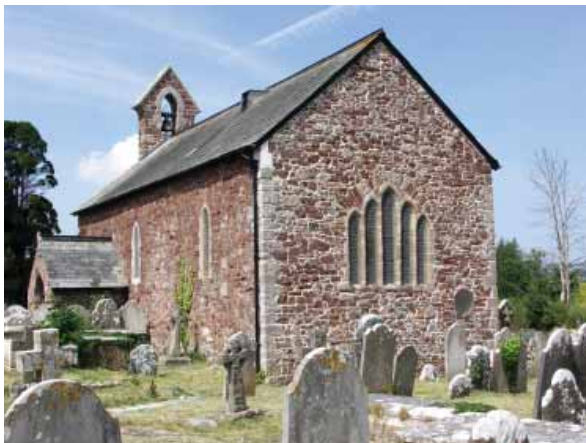
Fig 5 The church of St Nicholas

The Church of St Nicholas, (fig 5) with its origins in the 13th century, is the oldest building in the village and it is known to be connected to Belle Vue (fig 31) and Hill View cottage by tunnels possibly used for smuggling. Of the secular buildings that survive, the earliest date from around the

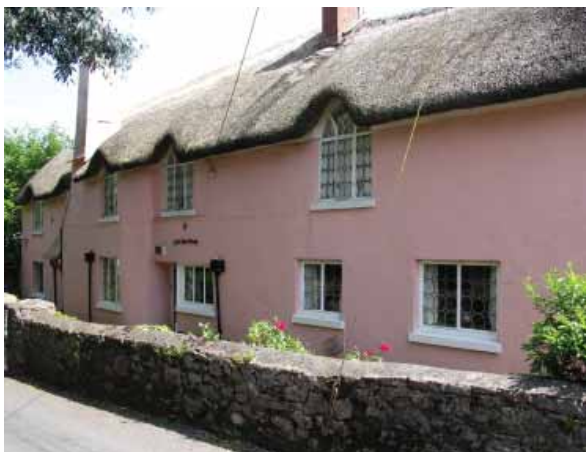
Fig 6 Old Stoke House

16th century, including Old Stoke House (fig 6) (in the Conservation Area), Home Farm, Pear Tree Cottage and Ringmore Farm. All are substantial farmhouses and, typical of their age, possess long, three or four room plans with a cross passage. The lack of burgage plots suggests the settlement did not develop in a formal or organised way, but rather evolved in something of an ad-hoc fashion fitting into the field system that existed in medieval times – and which is still largely preserved in the surrounding landscape. Ringmore, therefore, is essentially an agricultural village which, on account of its estuary-side location, enjoyed fishing and other maritime interest besides. Not least, it seems, and probably on account of its proximity to Shaldon and Teignmouth, it became quite a popular place to reside, with

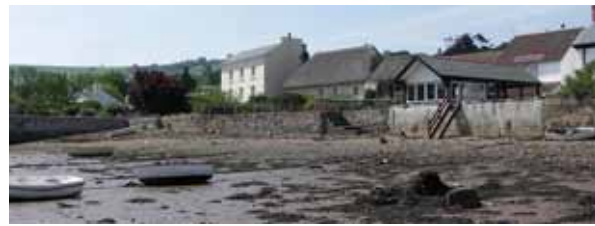
Fig 7 Foreshore walls

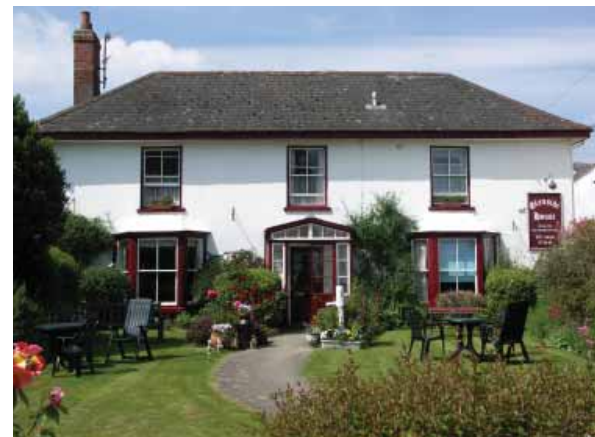
Fig 8 Glenside

curve of the village road past the entry to the church (formerly known as Church Hill) continued no further than the property now called Glenside (fig 8). Beyond it, in front of Glenside and across the site since occupied

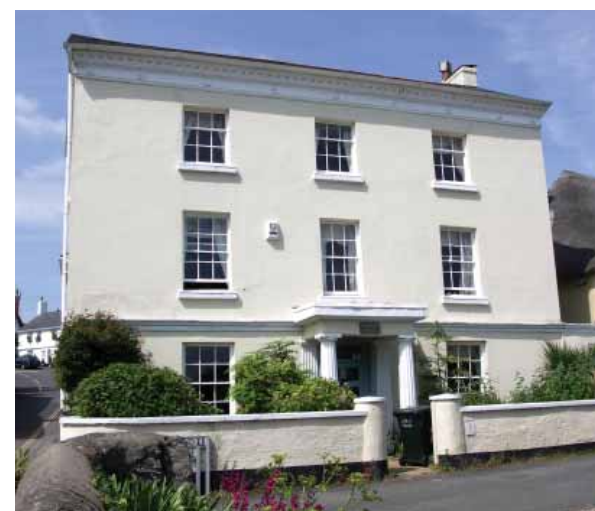
Fig 9 Strand House

by Strand House (fig 9), was an area of beach that extended only as far as the entry to Brook Lane when the tide was high. It is said that a mooring post was discovered when excavations were carried out in the front garden area of either Glenside or Rose Bank. The beach, and the Strand with its east-side garden plots similar to those along the Strand in Shaldon, were mostly reclaimed when the new estuary-side road to Shaldon was constructed – probably by the Newton

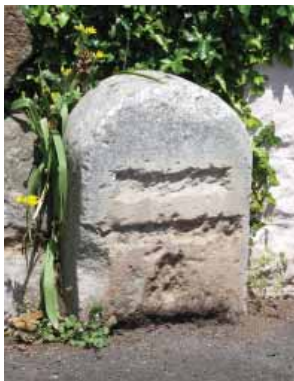
Fig 10 Milestone next to Church Walk

Bushel Turnpike Trust who erected the milestone next to the church entry which reads 'From Newton 5 miles'. This was also around the time the new bridge across the estuary to Teignmouth was opened (in 1827) so that Ringmore's accessibility was effectively transformed. Unlike Shaldon, however, Ringmore didn't rapidly develop into a residential resort – indeed, as many as five farms are said to have been working in Ringmore well beyond the middle of the 20th century. Rather, its expansion came late in the 20th century when the network of lanes around it succumbed to development in a ribbon fashion along them.

A milestone survives outside St Nicholas church; erected by the Newton Bushell Turnpike Trust in the early 19th century. The inscription read 'From Newton 5 miles' but was defaced in 1940 in response to the threat of a German invasion.

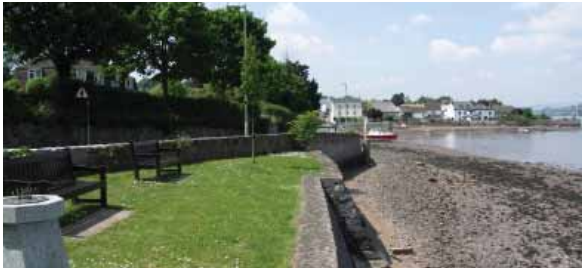
Fig 15 Ringmore walls

Walls are a significant feature throughout the Conservation Area contributing a great deal towards its interest and character. These are not only freestanding structures defining front and rear garden boundaries but also retaining structures built to reclaim land from the estuary or otherwise accommodate changes in level. The most extensive are those built to reclaim land for the creation of open plots along the Strand and for the construction of the estuary-side road that provided direct access to Shaldon. All have freestanding sections on top as a defence against flooding, and confirming the intention was not to provide quays. Extensive also are the walls on the south side of Ringmore

Road (fig 15 and 16), not only along the length beside the estuary that was built to retain the land cut into when the road was built in the 19th century, but also in the village itself where the S-bend was widened in the 20th century to improve visibility and provide for parking.

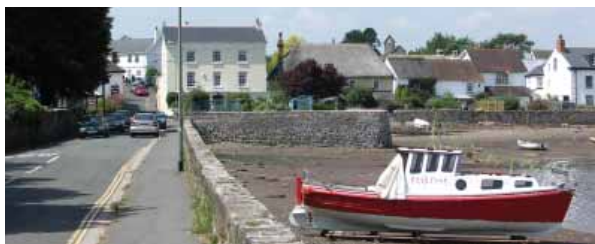
Fig 16 Sea Walls

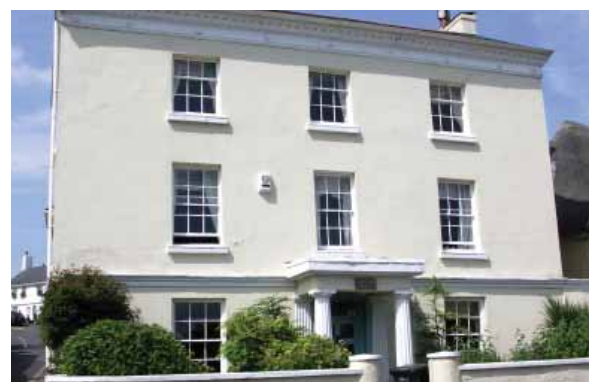
Fig 19 Strand House

The majority are smooth in texture, while a few of the more elegant examples still have traces of incised lining that was intended to create the appearance of finely-jointed stonework (as at Strand House (fig 19), Brook House and Farthings). It

Those to Enfield (fig 20) have contrasting panels, while those to Strand House are unusually rounded, presumably to blend agreeably with the curved returns of the wall (fig 21).

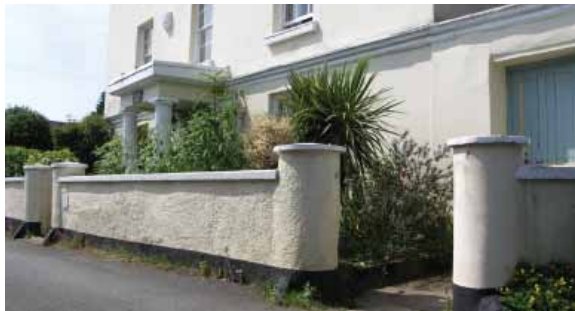
Fig 21 Strand House wall/piers

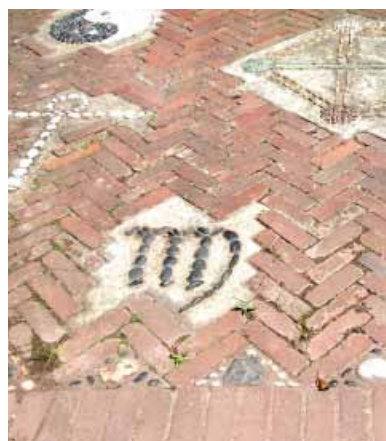
Fig 24 Paving along Church Walk

Historic surfaces, on the other hand, have largely been replaced or covered with tarmac. Off Church Walk, however, an area laid mainly with beach pebbles survives at the side entry to Farthings, while the garden path to Strand House has patterned, fawn-coloured pavers typical of the 19th century.

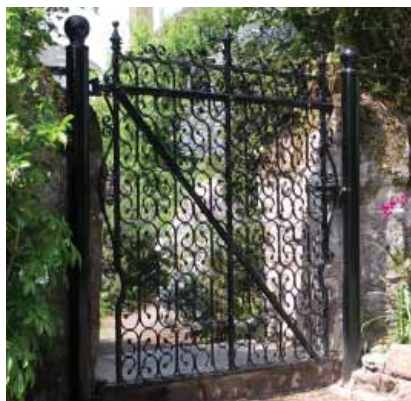
Fig 22 Gate at Rose Bank

Ironwork gates and railings also add a touch of refinement to the Area's character and appearance, none more so than the gate to Rose Bank (fig 22) with its integral posts, and the short lengths of railing at the Hermitage (fig 23) and to one side of the plot now used for parking opposite Glenside.

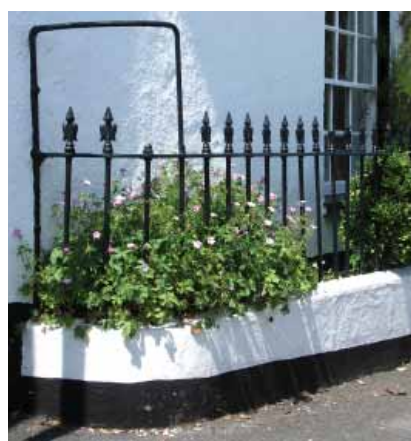
Fig 23 Railings at the Hermitage

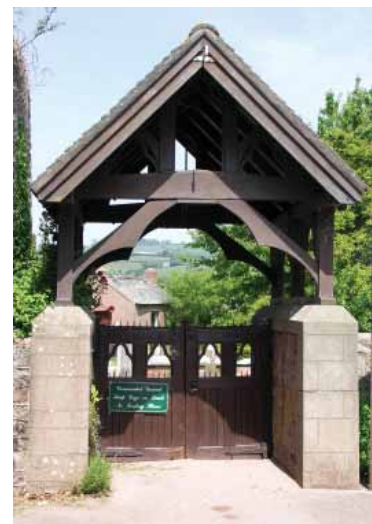
Fig 25 Lychgate

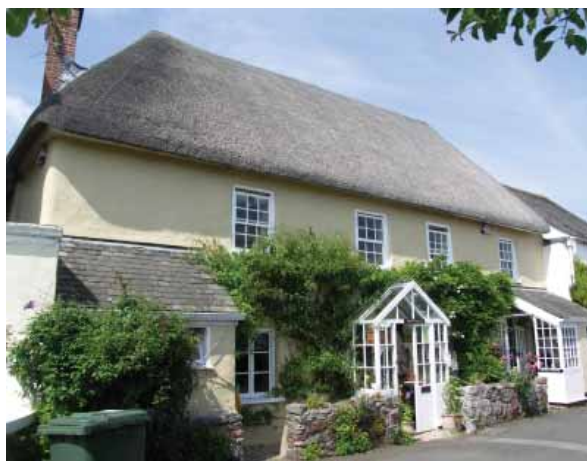
Fig 26 Doone Cottage

vertically proportioned sash windows as at The Hermitage (fig 33) and Doone Cottage (fig 26), as well as larger casements as at Sparrows Nest (fig 27), were made in the late 18th or 19th century when polite, classical styling was favoured and buildings like Enfield, Farthings, Brook House (fig 28) and Strand House (fig 19) entered the scene. Indeed, a few of the older village buildings were so 'refashioned' in the 19th century with slate roofs in place of thatch, sashes in place of casements and projecting bay and bow windows added that their vernacular characteristics were effectively swept away (as at Glenside and Rosebank). Today, therefore, classical features tend to dominate the village scene and contribute most towards its architectural interest.

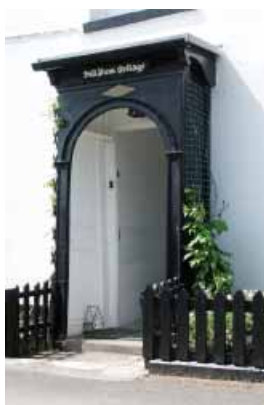
Fig 29 Hill View, hood with sides added

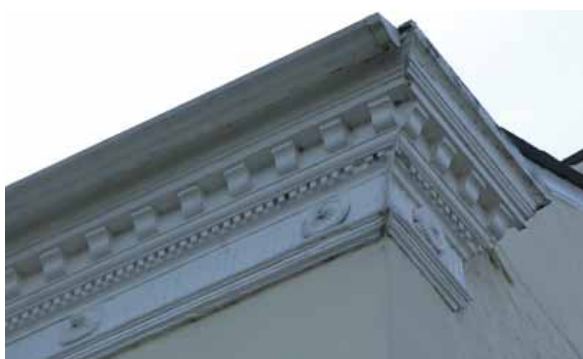
Fig 30 Cornice, Strand House

Sash windows are perhaps the most common feature, bringing much cohesion to the village scene. A few have a '2 over 2' glazing pattern, but the majority have '6 over 6' and look their most elegant when arranged symmetrically across front elevations (as at Farthings, Brook House, Strand House and others). Many original six-panelled doors also survive, and while the open porches to Strand House and Brook House are in their original state, the one to Enfield has been subsequently enclosed. Examples of door hoods and trellised porches are also in evidence, as are a number of intricate cornices at the eaves (as at Strand House). Other architectural embellishments are relatively few, with just two examples of rusticated quoins (at Belle Vue and Hill View Cottage), one of pilasters (at Enfield) and two of horizontal banding (at Brook House and Strand House (fig 30), the

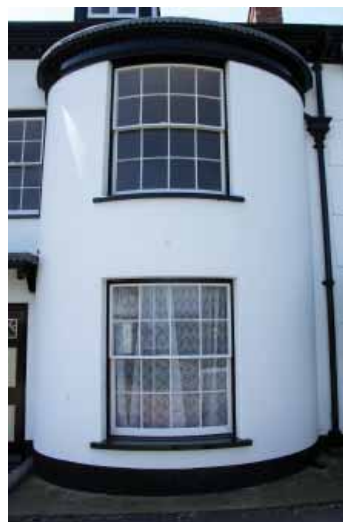
Fig 31 Bay of Belle View

parapet (the eaves to other slated roofs are either close-boarded or projecting, with neither the more dominant form). Canted bay windows are a particular feature of several houses though usually as later additions, while the only bow window in the area is impressive indeed, being two-storeys in height and occupying more than a third of the building's front elevation (this is at Belle Vue).

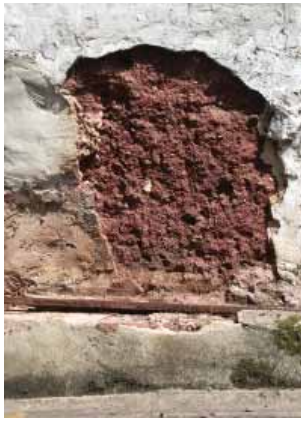
Fig 32 Exposed cob of outbuilding

Dominant throughout the area and bringing much visual unity to the village scene, are rendered or colour-washed facades that mask and protect cob or rubble-sandstone structures beneath.

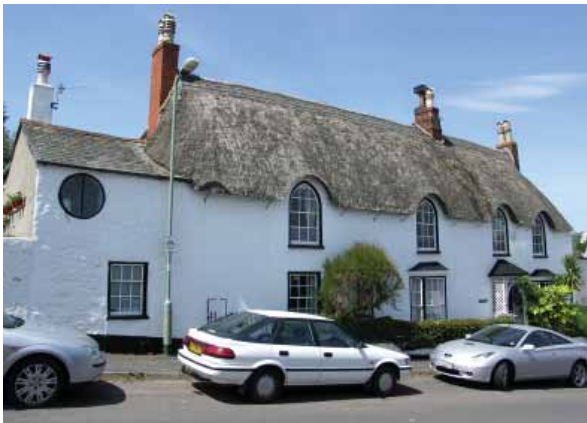
Fig 33 The Hermitage, 2007

But for one or two outbuildings, such as those to the south of the Hermitage (fig 33), the render is painted; most commonly in white or pastel shades that have the advantage of preserving the dignified character most buildings possess and bringing visual harmony to the village scene..

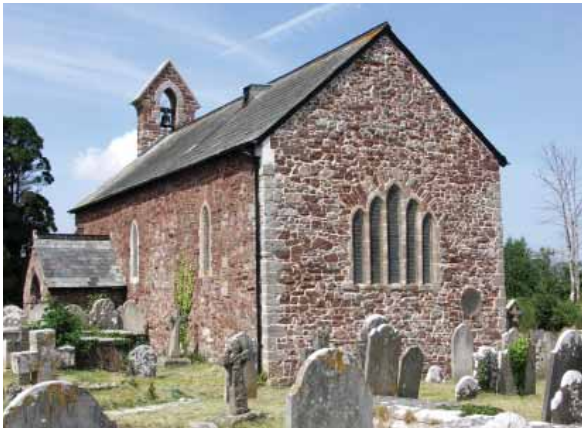
Fig 36 St Nicholas' church

Buildings with a natural stone face are as uncommon as those of brick, and again, only one example exists within the Conservation Area. This is perhaps not surprising as the locally sourced red sandstone is a friable and porous breccia which is a mix of stone fragments in a sandy matrix, so that a protective coating is normally required to make it serviceable. Nevertheless, it adorns

St Nicholas' Church (fig 36) and makes it one of the most locally distinctive buildings in the village. It also tends to distinguish the building as not being in domestic use. The stonework exposed in the farm building (fig 37) just outside the Conservation Area opposite Ringmore House does likewise, but as is often the case, it has been heavily mortared to maintain its integrity. This building is, however, a rare survivor in the village, being unconverted and with much of its 'industrial' character still intact.

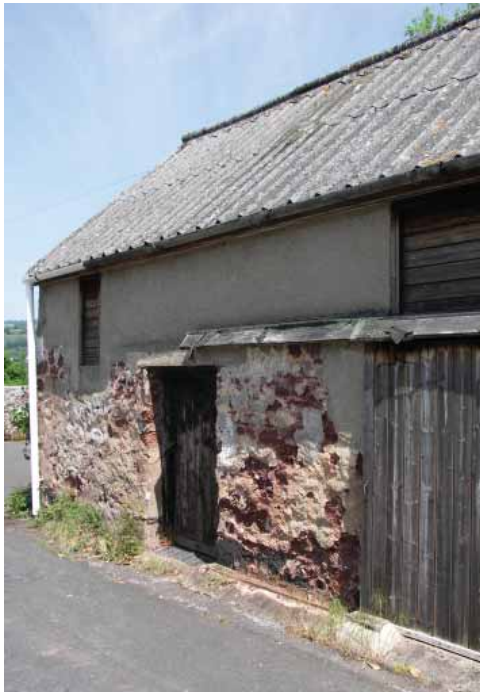
Fig 37 Exposed stonework in a farm building
