Dunchideock Conservation Area

Character Appraisal

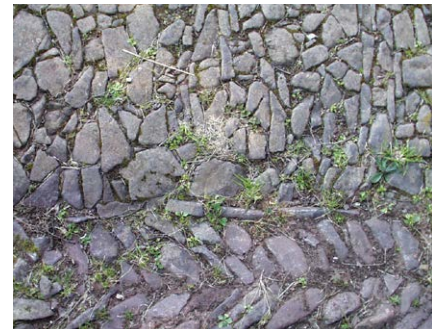
The local basalt is a very durable material which is good for cobbling.

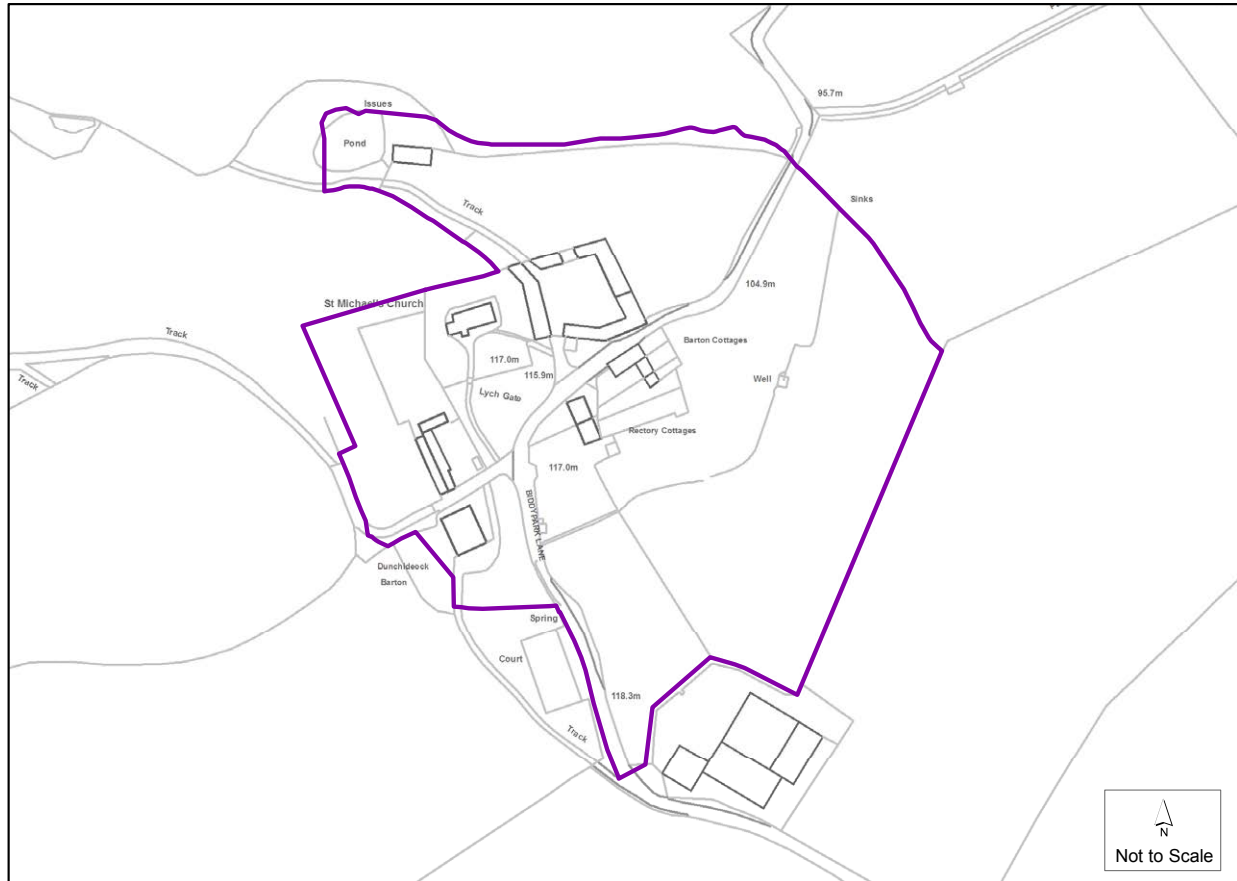
- Most of Dunchideock may have considerable archaeological remains relating to its origins and medieval growth. In view of the unusual level of understanding of the historic plan of the hamlet and the undisturbed sites of several medieval buildings, an Area of Archaeological Potential (on the map on the next page) has been identified to take account of these and the areas of ancient settlement.

- Archaeological remains in Dunchideock are particularly important. An Area of Archaeological Potential has been identified, taking account of its origins and development. Adequate consideration should be made of the potential impact upon the historic environment of any new development proposals within the Area of Archaeological Potential that involve significant ground disturbance, or affect a historic building, to allow the appropriate mitigation to be implemented. This consideration may result in the need for a planning application to be supported by the results of a programme of archaeological investigation.

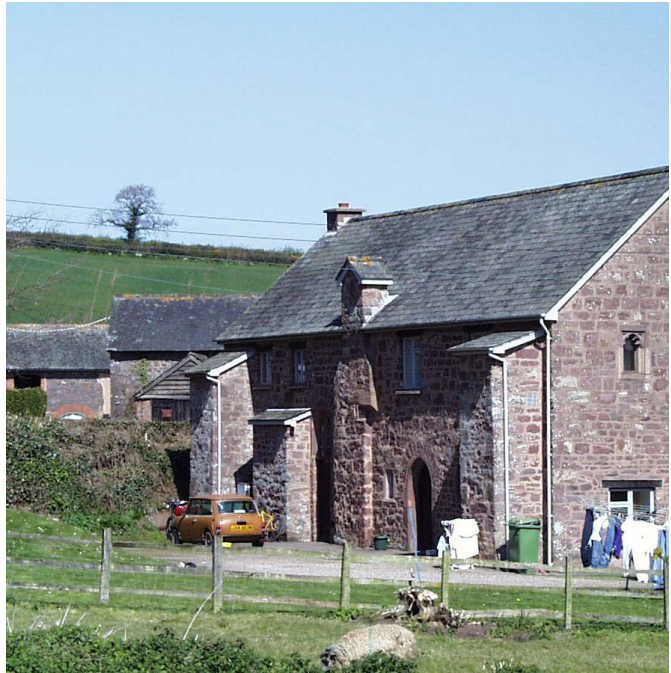
Rectory Cottages

The best buildings are the early 15th century parsonage, (Rectory Cottages), with its gothic stone doorframes and cusped windows and the church, mainly of late 15th century form, heavily restored in the 20th century. Dunchideock Barton's restrained design is typical of its period, a theme carried on by the austere courtyard barns east of the church. Barton Cottages clearly incorporate fabric from the 16th or 17th centuries.

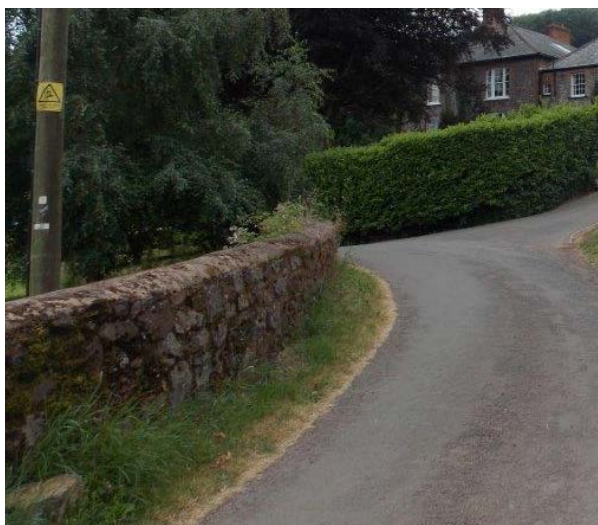
Stone Wall

For the most part Devon banks and mixed deciduous hedgerows form enclosure. This gives the impression that the countryside is essentially uninterrupted by the settlement and reinforces its dominant character over any evidence of urbanity. Some laurel and privet are found but their use ought not be extended. Where stone walls are found, as around the churchyard, they are constructed of local stone laid in lime mortar with a coarse aggregate.

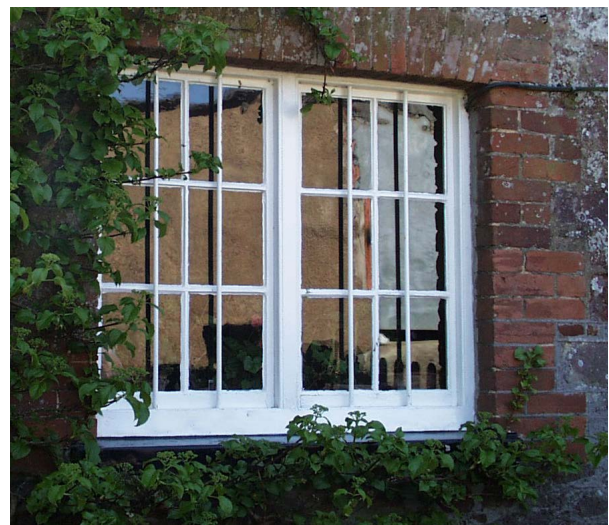
Windows

Timber windows of various ages are found within the hamlet and contribute positively to its character.

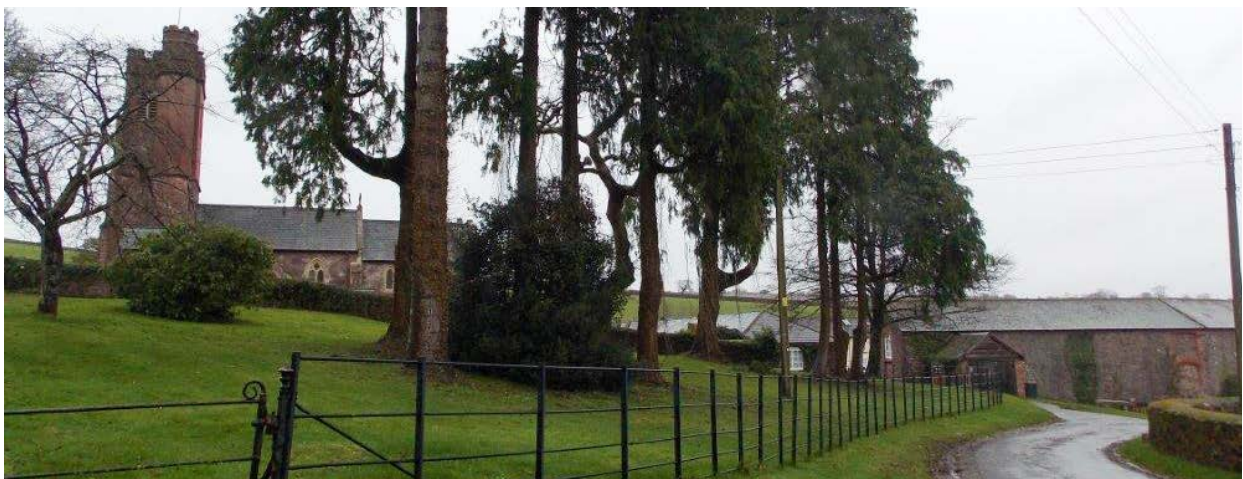
The Green

The green is an important open space within the conservation area that adds to the setting of the church, chest tombs, Rectory Cottages and range of farm buildings. The mature trees are a dramatic feature within the settlement. The open space currently has a traditional metal fence enclosing it which is appropriate for the character of this important area.

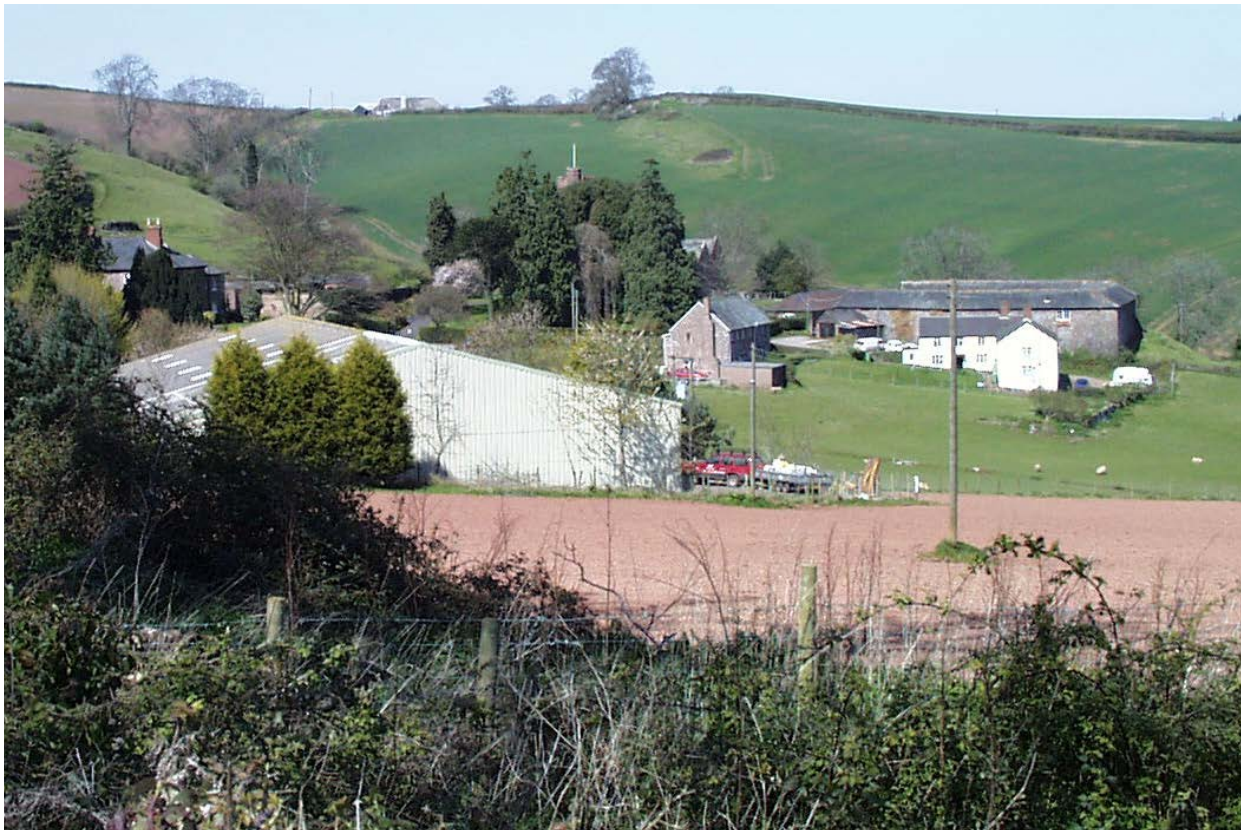
Modern farm buildings

8:1 Farm Buildings: The modern farm buildings to the south are rather unattractive. Perhaps a copse of deciduous trees could be planted to screen these?

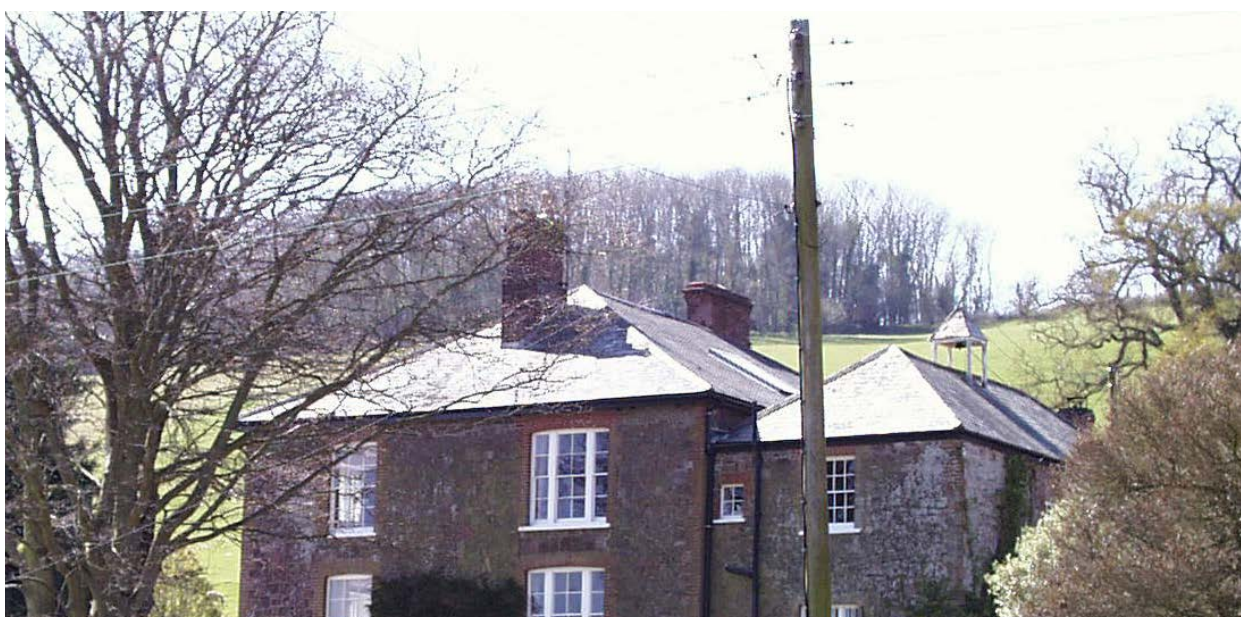
8:2 Overhead Cables: Power and telecom poles and wires detract from many views within and around the conservation area

Poles and wires detract from many views

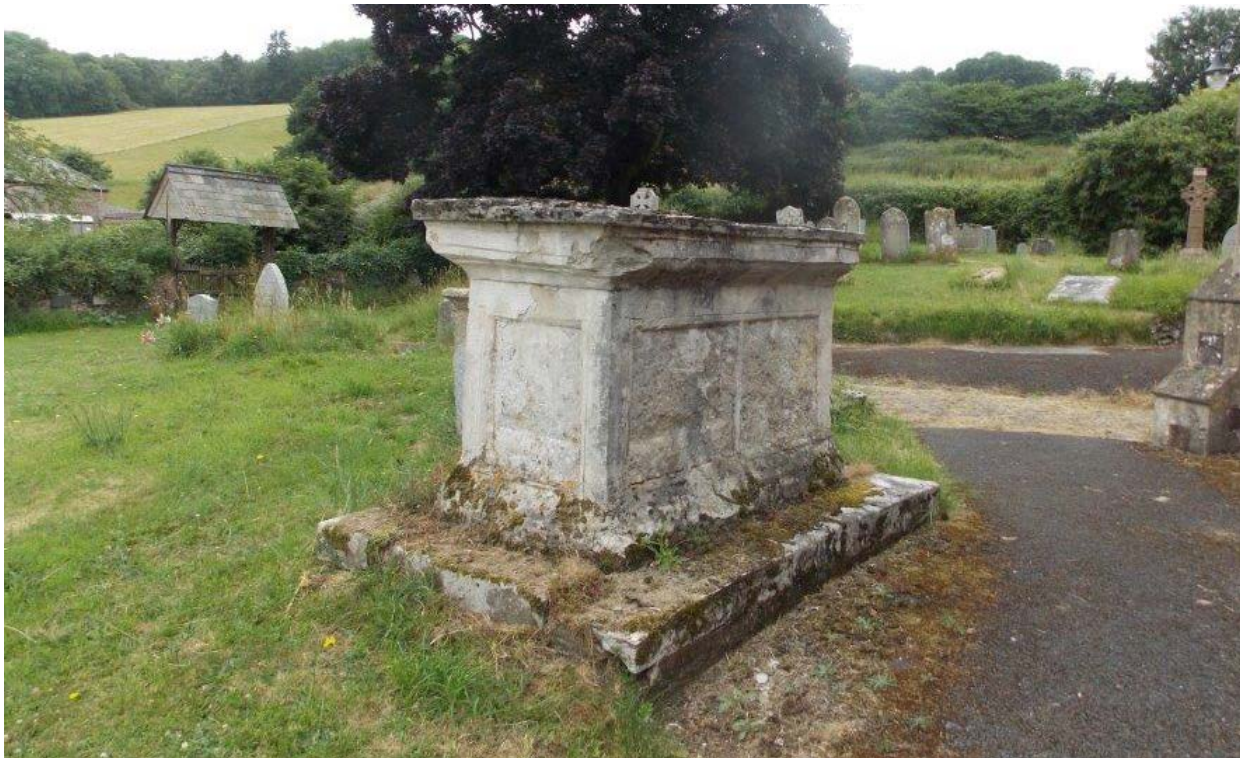
Chest tomb

- The chest tomb within the graveyard of St Michael and All Angels requires some repair/attention. It has deteriorated with a large crack to one side.
- Rectory Cottage is a key building in the conservation area particularly as the area is so small. When the fenestration to Rectory Cottages is due for renewal it would benefit from a more sympathetic design more appropriate to its 15th century origins.
- The walled garden to the south of the church is not listed and is constructed of cob and natural stone. It is a strong and interesting feature of the conservation area; being cob it is important to maintain with cement free renders.

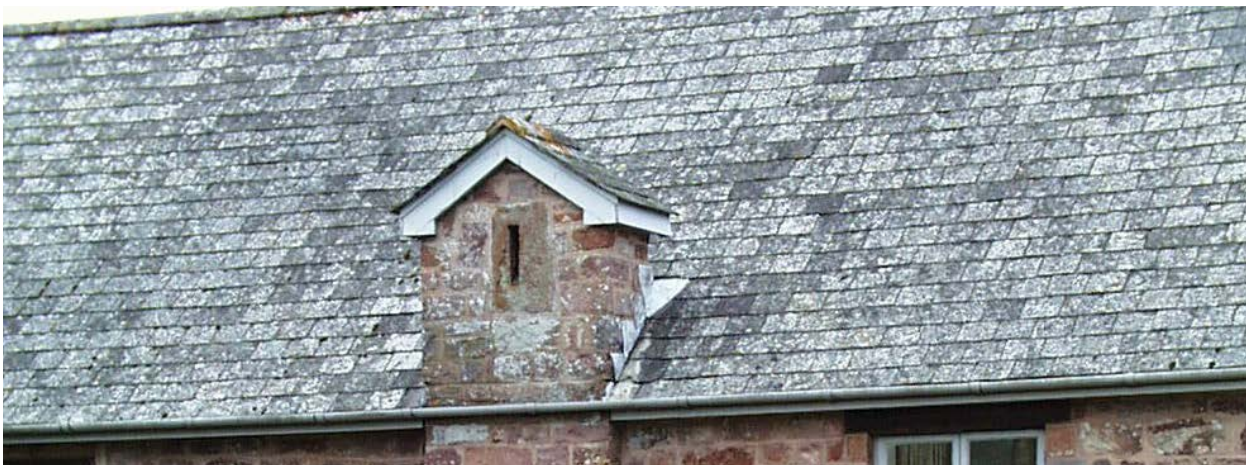
Blue-grey natural slate roof

Roofing: Blue-grey natural slate, with black or naturally patinated corrugated iron on outbuildings.

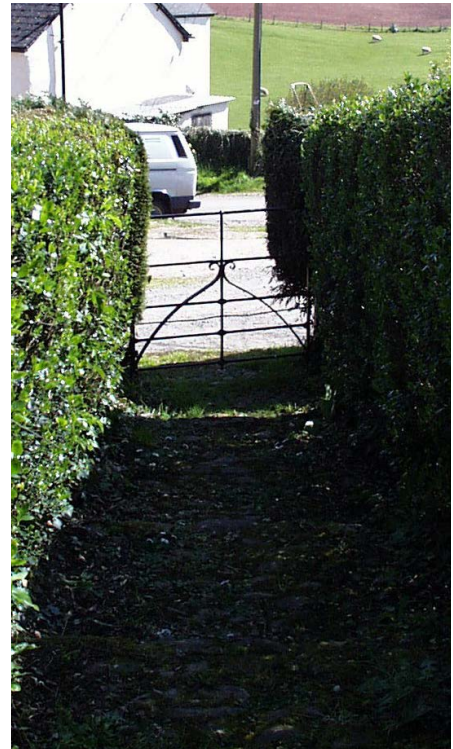
The Church path has a lot of character

7:1 Surfacing: Some surviving remnants of historic surfacing illustrate the type of treatments which were used in times past. The cobbling along the church paths incorporate stones probably gathered from fields and/or streams in the immediate vicinity. Laid in earth and tightly packed they produce hardwearing surfaces full of character and locally distinctive. Other parts of the area are likely have been treated in a similar way in the past.

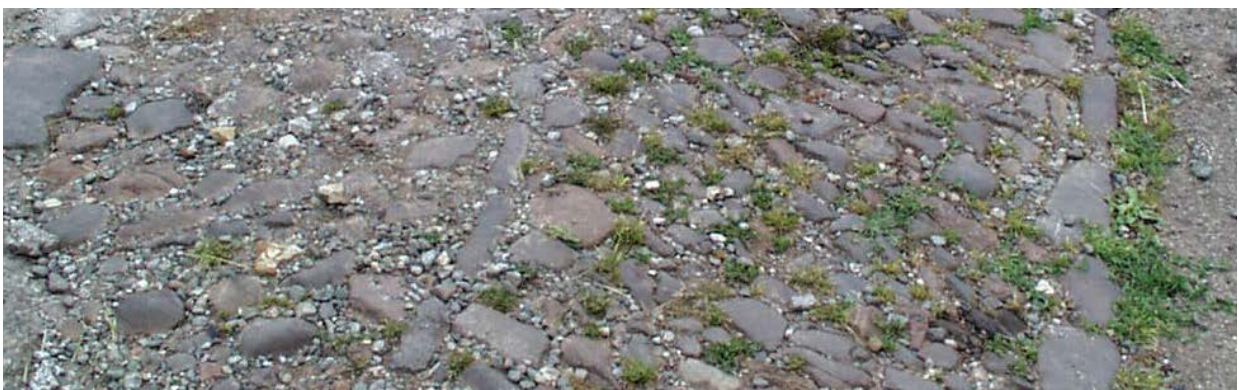
Cobbling adjacent to the Barton farm buildings

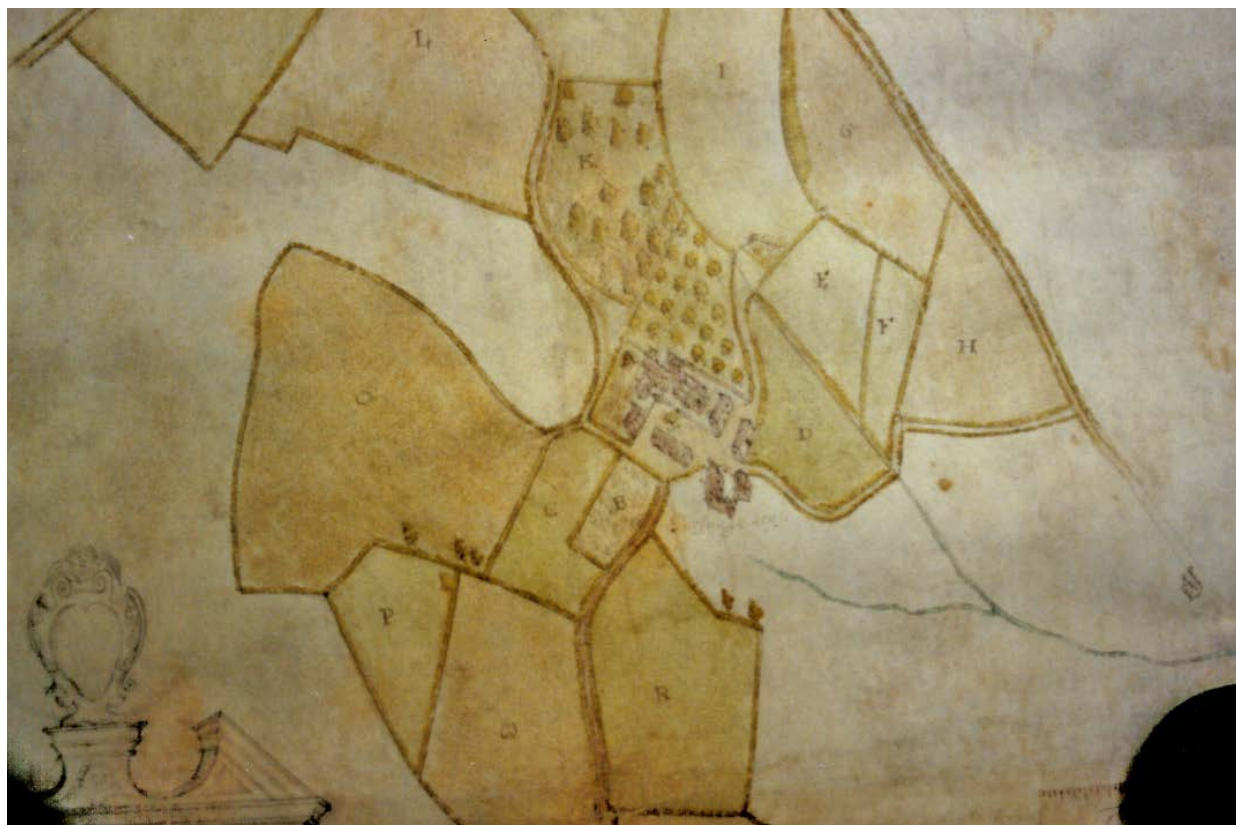
1652 Map Detail of Village. Note 'Parsonage House, at bottom.

Dunchideock is very fortunate in that an estate map of 1652 survives in the Devon Record Office, Exeter. This is a pictorial map, with the field boundaries, roads and streams in plan form. Buildings and trees are shown in two dimensions. The map is reproduced in Appendix 3 and shows that the buildings had changed little between then and the tithe map of 1843. The important early 15th century parsonage house has a wing to the south east and the present farmhouse, isolated to the east, may have been part of it, making a typical medieval courtyard plan. Earthworks to its south may be partly destroyed hedgebanks, enclosing former settlement areas.
